Service Disruption Updates

May 9, 2025 – Operational Technology Network Disruption

May 20, 2025 – San Leandro Fault & Equipment Fire

BART Board of Directors | June 26, 2025

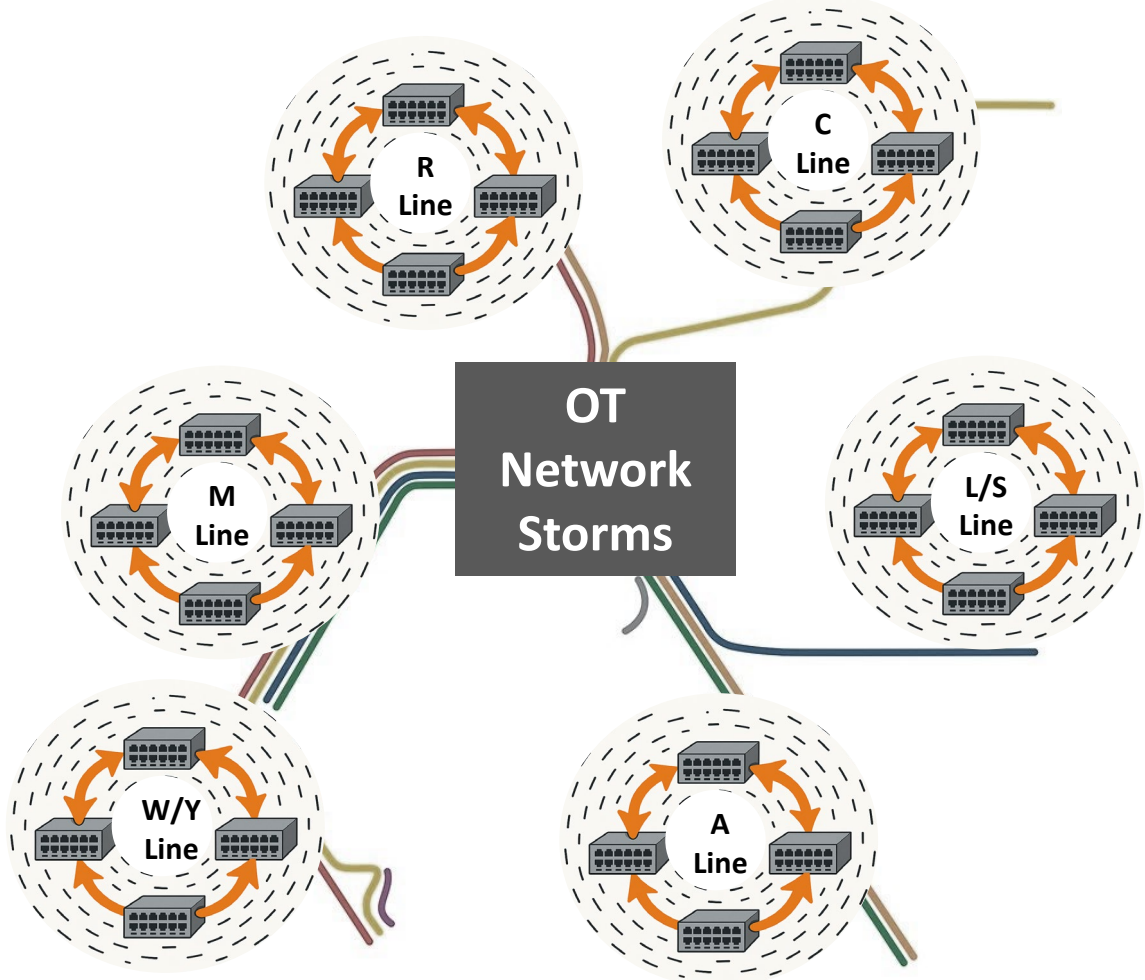
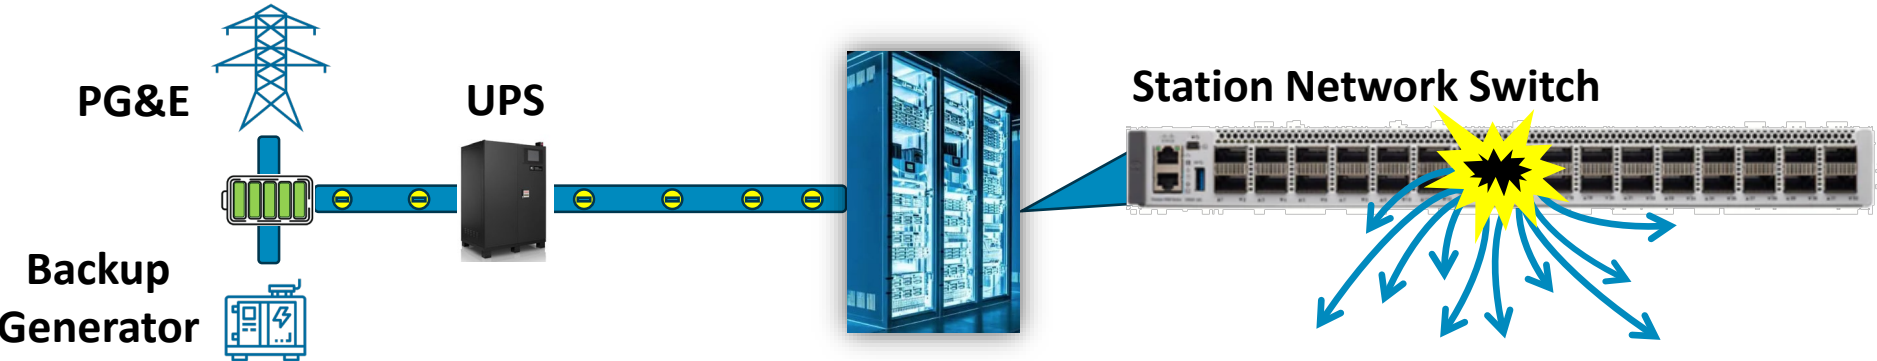
Investigation Findings

- Power transferred from generator to PG&E
- Power interruption < 1 second
- Loss of light in fiber
- Internal component failure in the network switch
- Network switch initiates an auto recovery feature creating a line-by-line network storm of data traffic

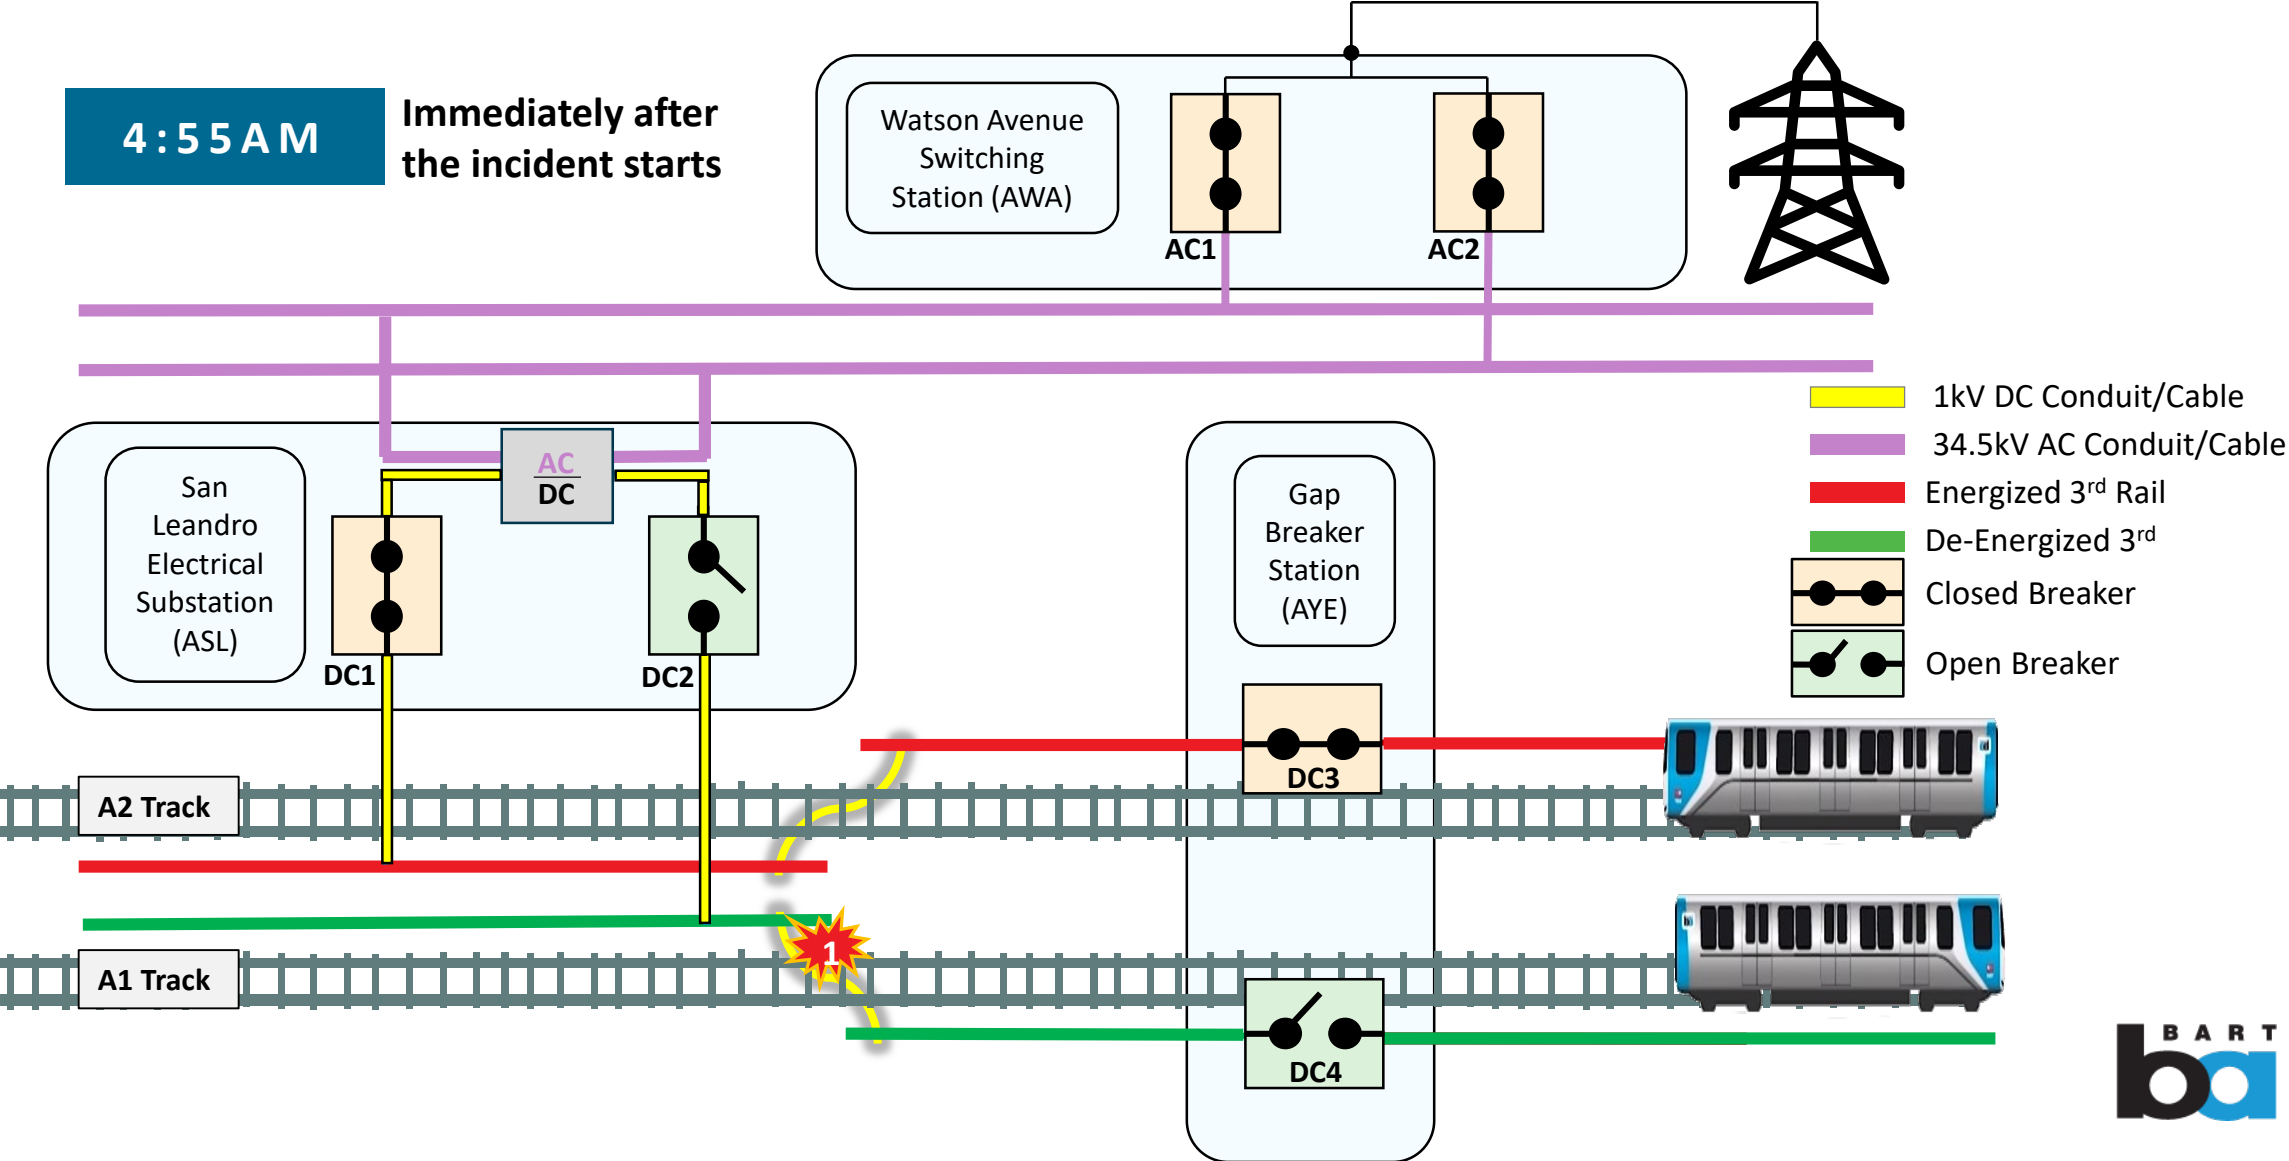
Sequence of Events

**4:55 AM –
5:05 AM**

- Breakers open and reclose multiple times
- Communication, Control and Fiber Cables Damaged
