► C Line Summary and Update

June 21, 2022

Train 323 (T323)

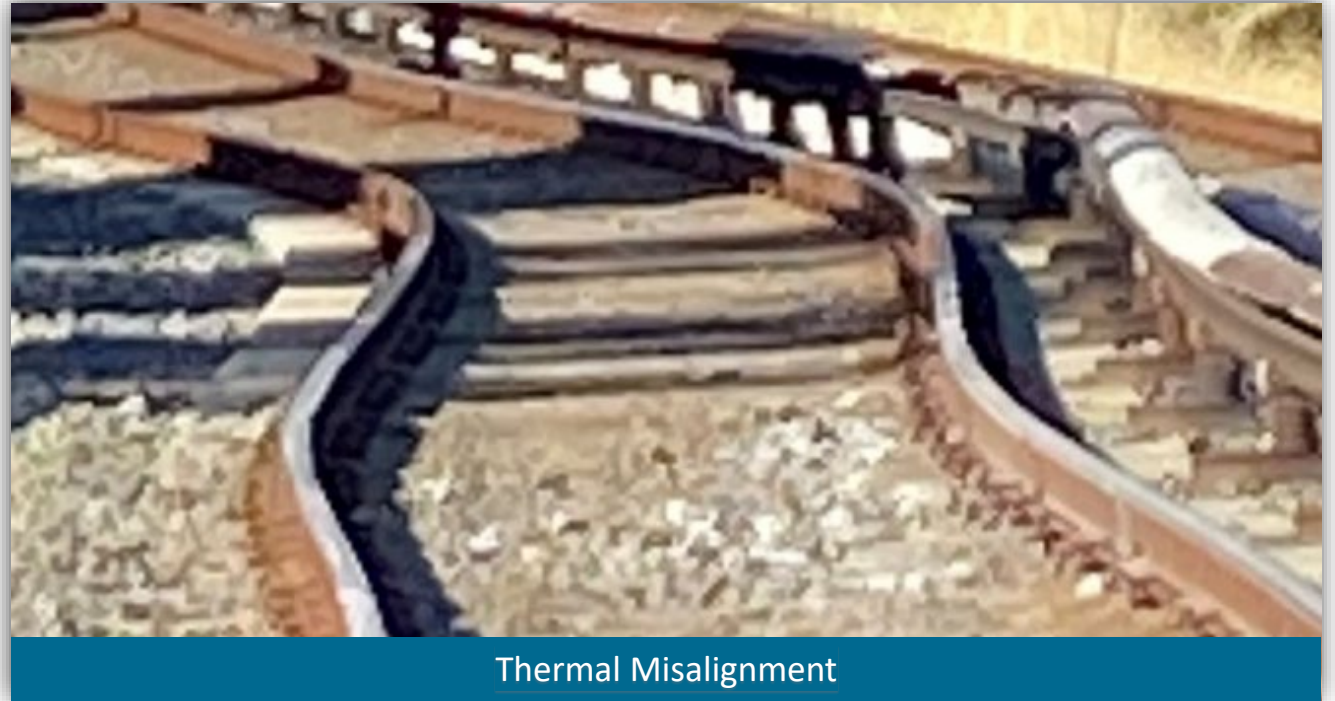
Thermal Misalignment

- 10-car legacy train
- Southbound
- C2 Track
- 9th & 10th cars derailed
- Passed over a thermal misalignment
- 3 Patrons/1 employee transported for injuries sustained in the event

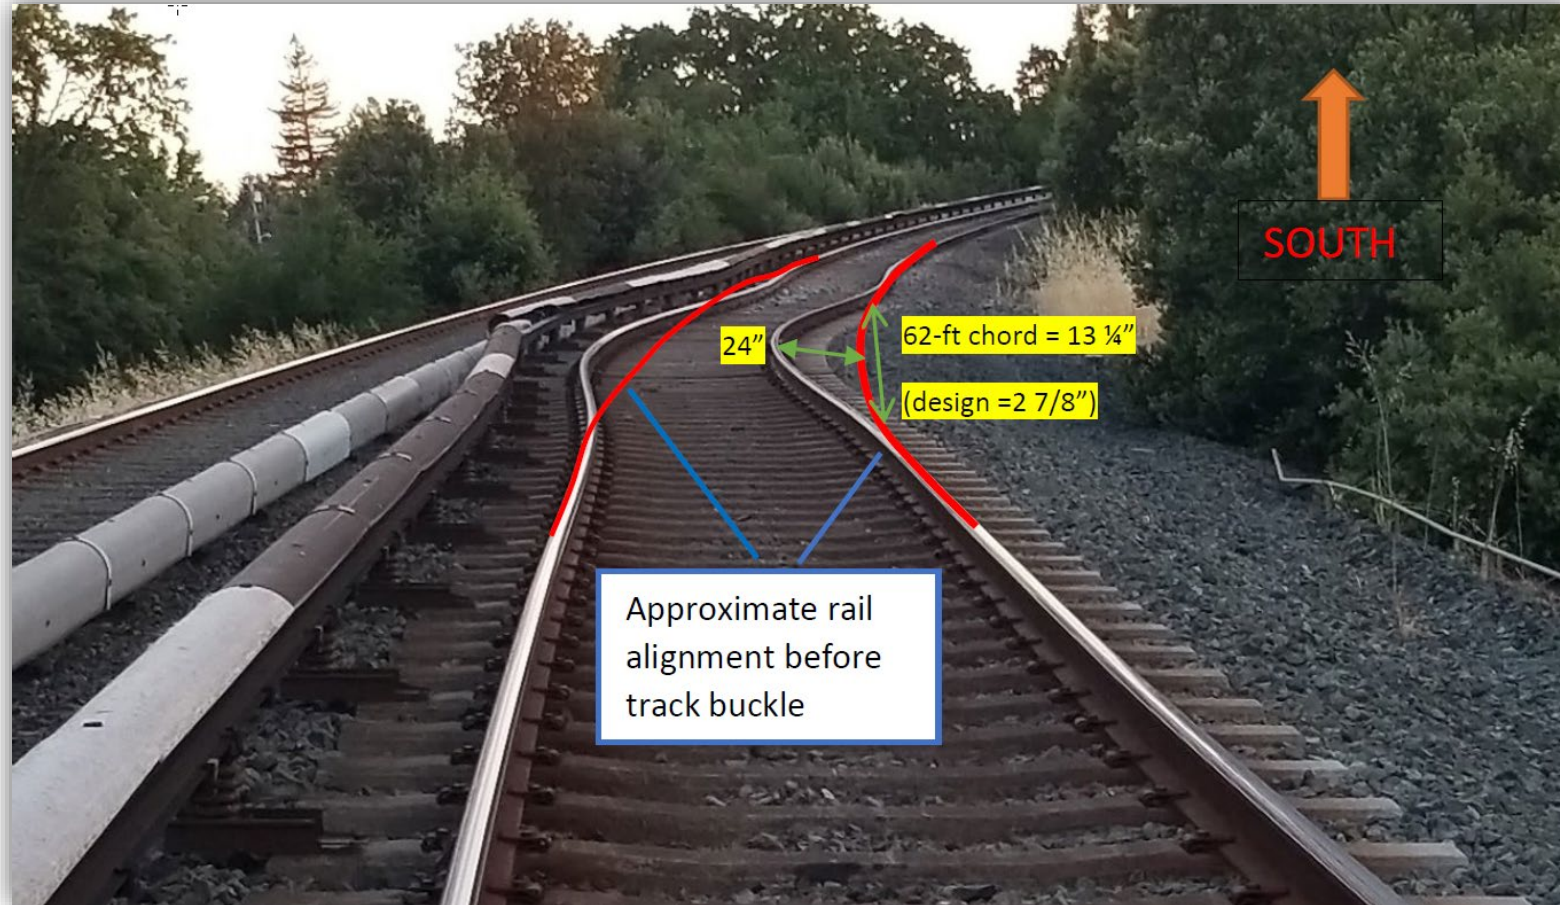
Effect

- 24" deviation in curved rail
- C2 3rd rail encroached C1 Track
- Ballast displaced
- Concrete ties shifted

Thermal Misalignment:

"A lateral shift of a portion of a track alignment, most commonly occurring at a curve cause by an extreme heat event"
