► Root Cause Investigation Update on M-Line Service Disruptions

January 22, 2026 | BART Board of Directors Meeting

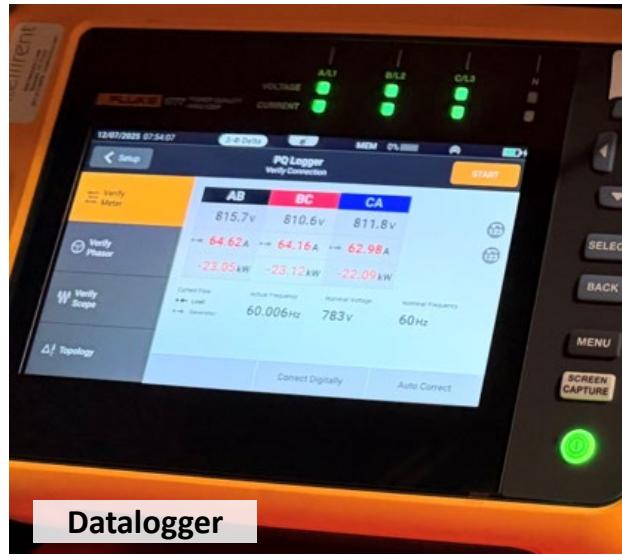
- Load monitoring tests were performed at BART traction power substations.
- Higher incoming medium voltage and phase unbalance from Switching Station
- Increase in DC ripple observed.

- Negative return mapping was performed through the TBT to field verify the connections
- Two areas of low resistance were found on the M1 and M2 track through the Transbay Tube (TBT), and have since been resolved
- Negative Grounding Device (NGD) at Powell (M30) was found to be shorted
- Crossbonds had been removed in 2020 to support TBT projects

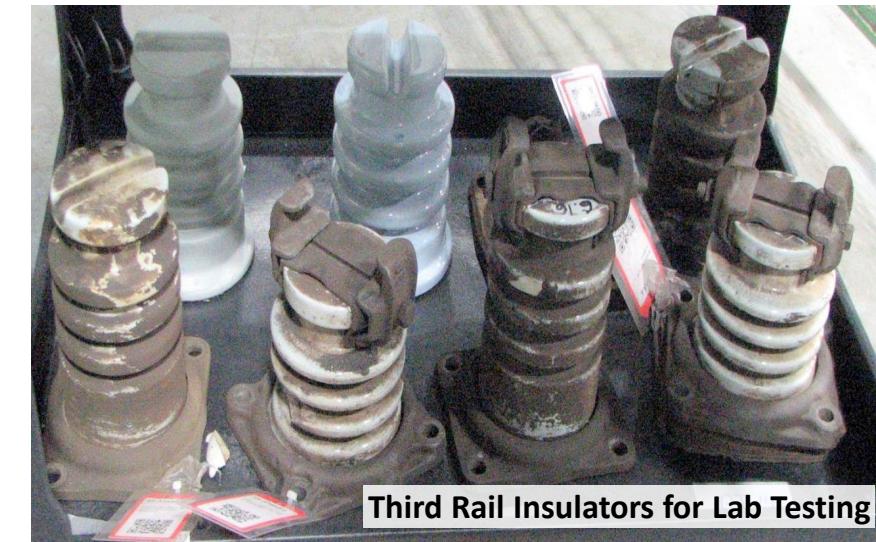
Third Rail Insulators

- Third rail insulators and associated assemblies were inspected and tested at two different offsite laboratories.
- Insulator condition is consistent with normal aging and environmental exposure expected within tunnel installations.
- Rail relay storage practices that involve cutting notches into cantilever brackets to store ribbon rail may impact insulator.
- The failure mode in incidents where insulators were involved, was carefully examined to identify the type of insulator failure.

New Insulator Type (Fiberglass) or with Cycloaliphatic Epoxy Coating Research	In-Progress
	Complete upgrade and bring on-line KTE Substation	In-Progress
Wayside

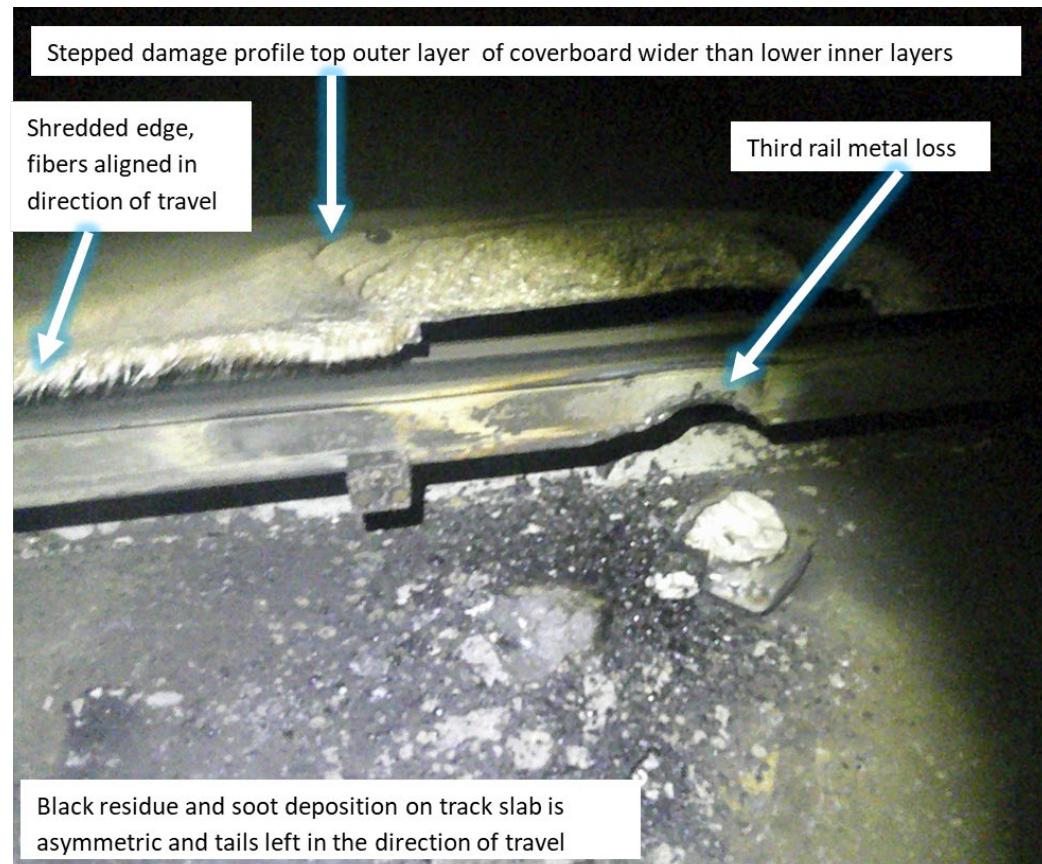
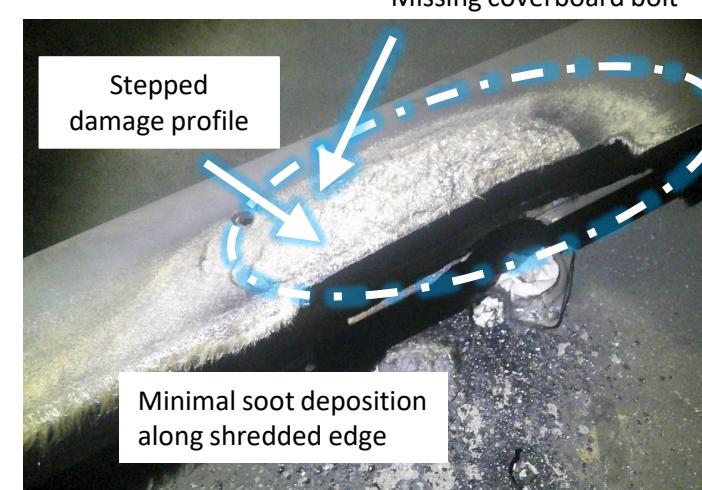
~ 4' H residue, vertical, aligned with hole in back of coverboard. Fans left in direction of travel.

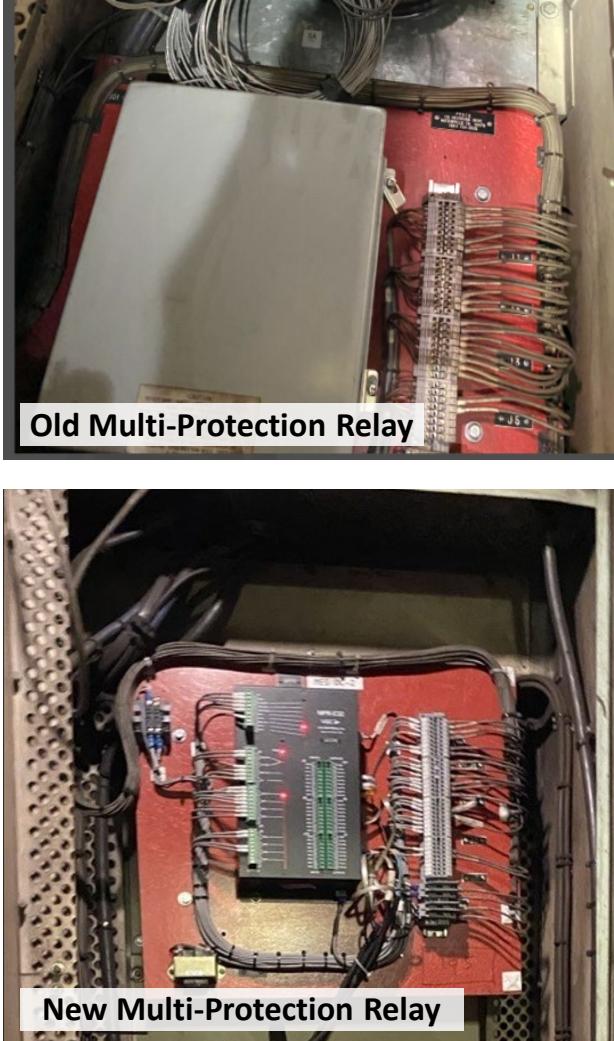
Old Multi-Protection Relay

- DC Circuit Breakers control power to 3rd rail and include integrated overload/overcurrent protection.
- Multi-Function Protection Relay (MPR's) provide advanced sensing and triggers breaker trips during specified overcurrent events.
- MPR settings at Transbay Tube (TBT) Gap Breakers were previously disabled to prevent nuisance trips, relying only on basic breaker protection.

Transbay Tube (TBT) Gap Breakers were previously disabled to prevent nuisance trips, relying only on basic breaker protection.

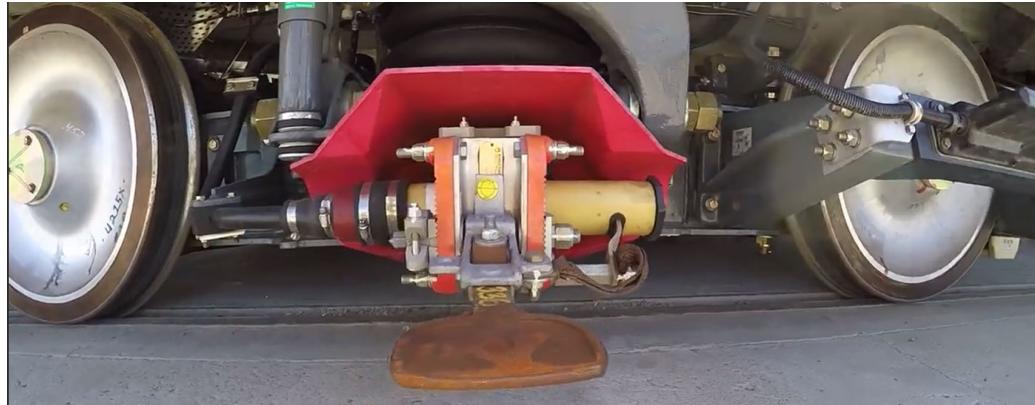
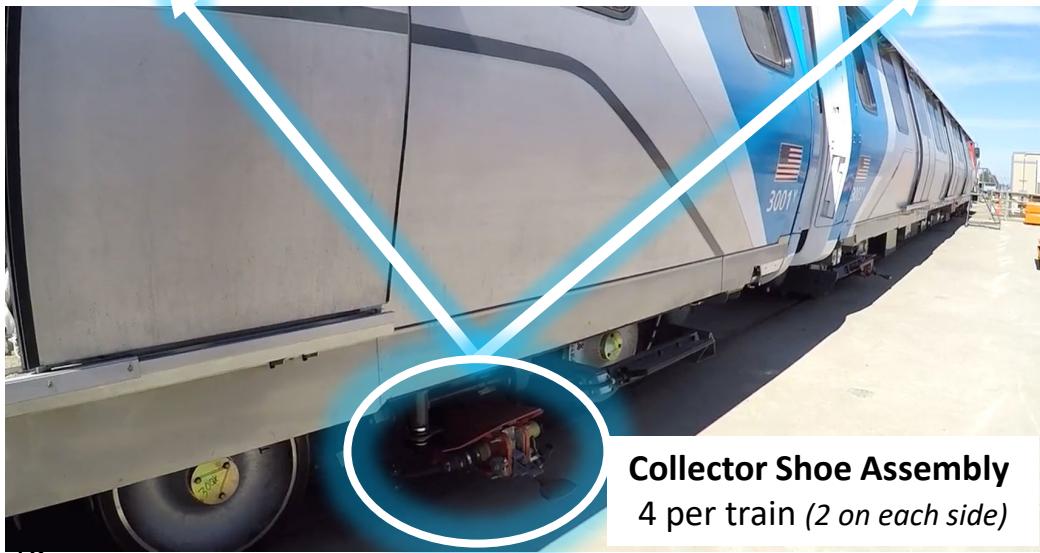
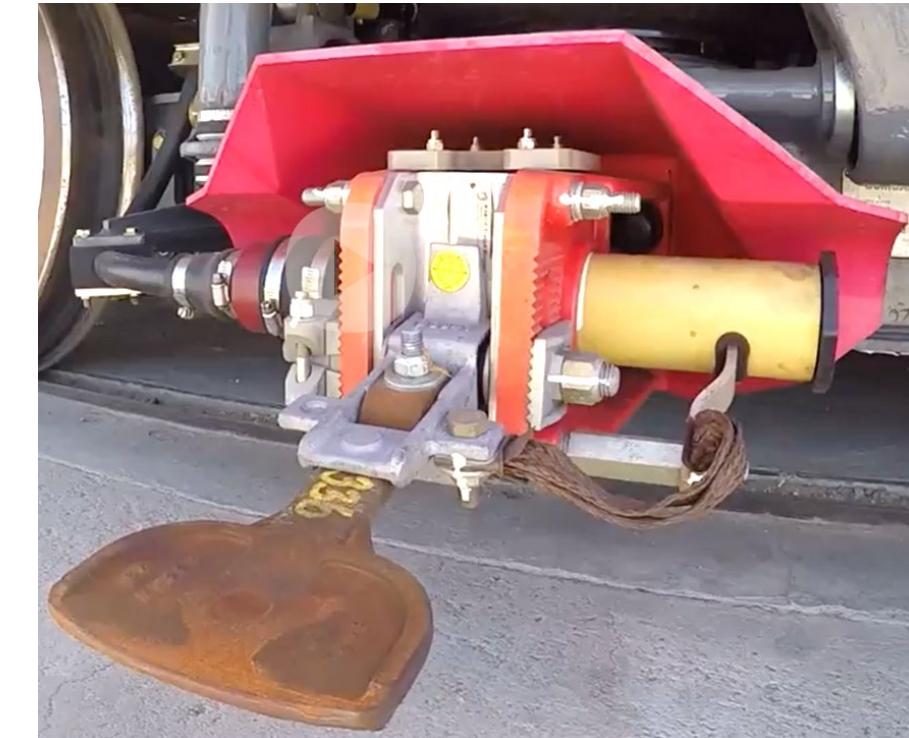
Collector Shoe Assembly

- Mounted between the wheels of each truck on both sides of the car
- The paddle rides along the 3rd rail and draws current to power the train and auxiliary equipment
- Assemblies sent to forensic laboratory for further inspection and analysis
- Assemblies include paddles and fuses

Further Testing of Collector Assembly	In-Progress

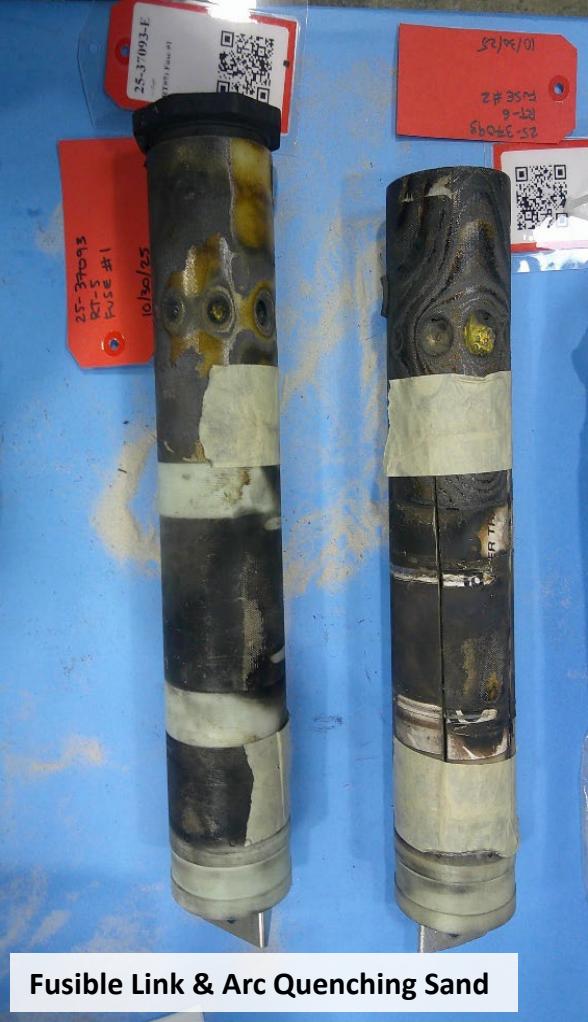
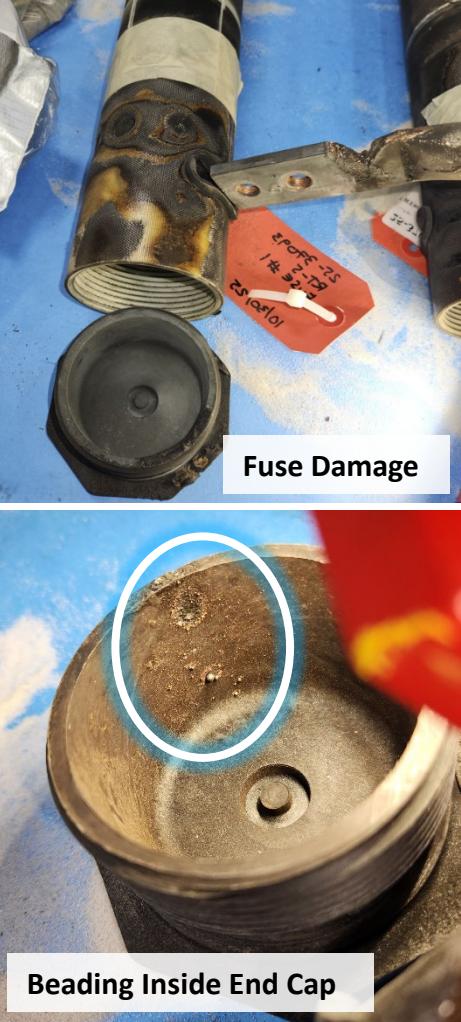
Fuse Assembly

- Incident vehicles and non-incident vehicles (for comparison) inspected
- Each car is equipped with four fuses, two per side, rated at 600 A RMS providing redundancy and current limiting protection.
- Four collector assemblies were sent an offsite independent laboratory for further forensic inspection and testing including x-rays and elemental analyzer tests.
- Inspection of three out of the four fuses confirmed non-standard vehicle fuse failures, not observed elsewhere on the system.
- Additional analysis of vehicle data is in progress.

Conduct Shock and Vibration study on the fuse assembly and shunt connection
Evaluate possible collector shoe loss prevention measures

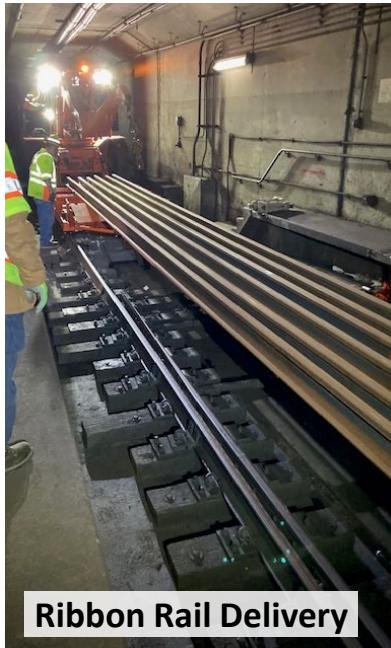
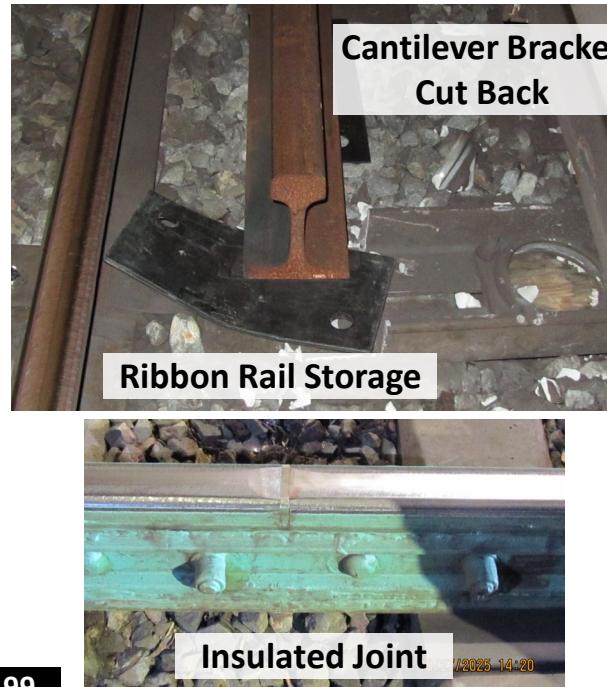
Rail Relays

- Stored ribbon rail was found in the vicinity of one of the arcing incidents.
- Third rail cantilever brackets have been occasionally cut back to accommodate ribbon rail storage for future rail replacement.

Vehicles Operation	N/A
	Collector Shoe Third Rail Interface Review	In-Progress
	Rail Relay / Insulated Joints Review/Modification	In-Progress
	Direct Fixation Pads	In-Progress
	Removed stored ribbon rail on the M Line	✓

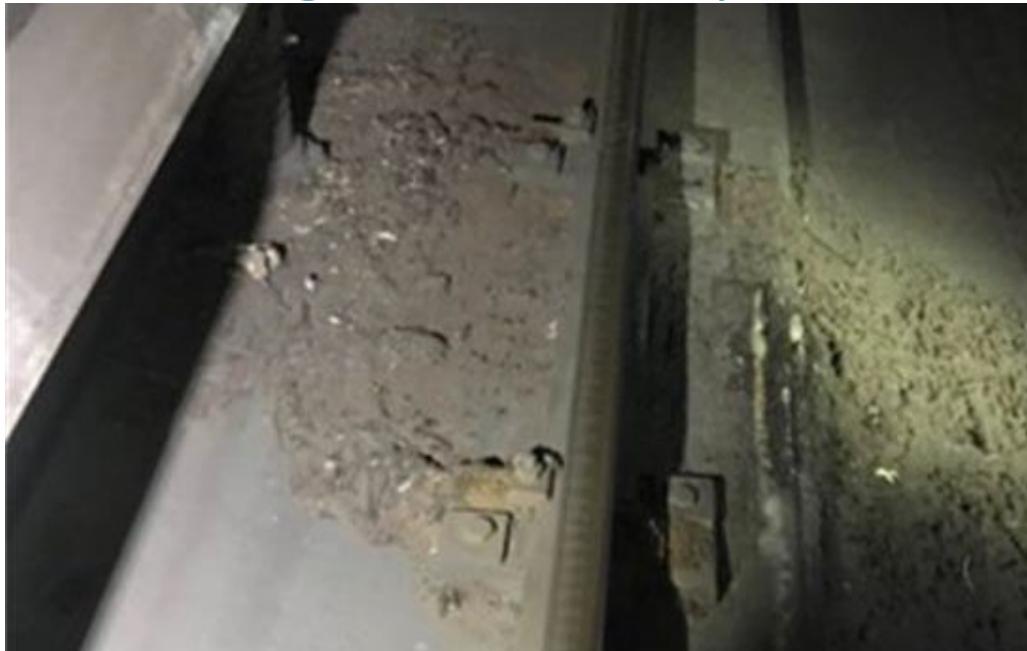
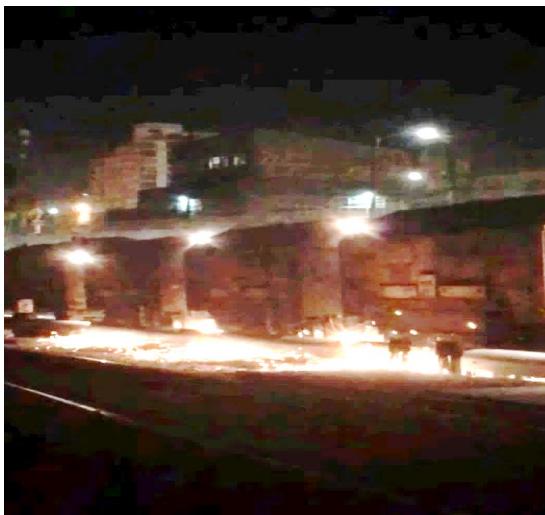
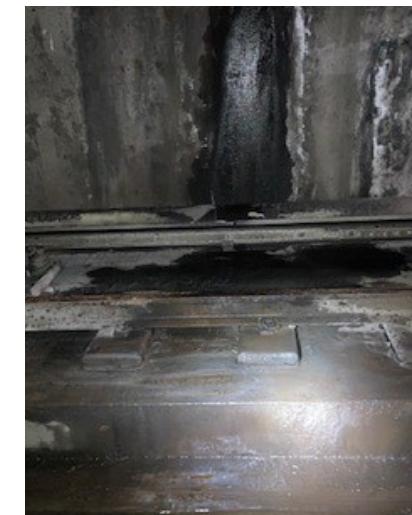
Environmental Factors

- Rail grinding creates dust that can collect on surfaces inside of tunnels.
- Wet environment resulting from water intrusion, trackway puddling, and elevated humidity in underground stations

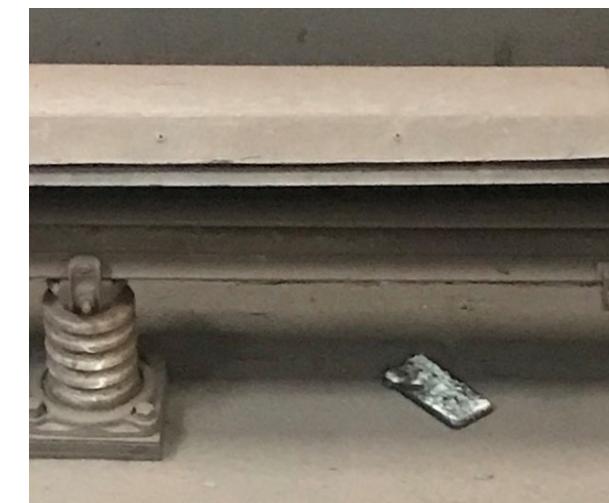
Human or External Factors

- Debris (e.g., garbage) especially that which contains conductive materials such as aluminum cans and mylar balloons can cause contact rail arcing.

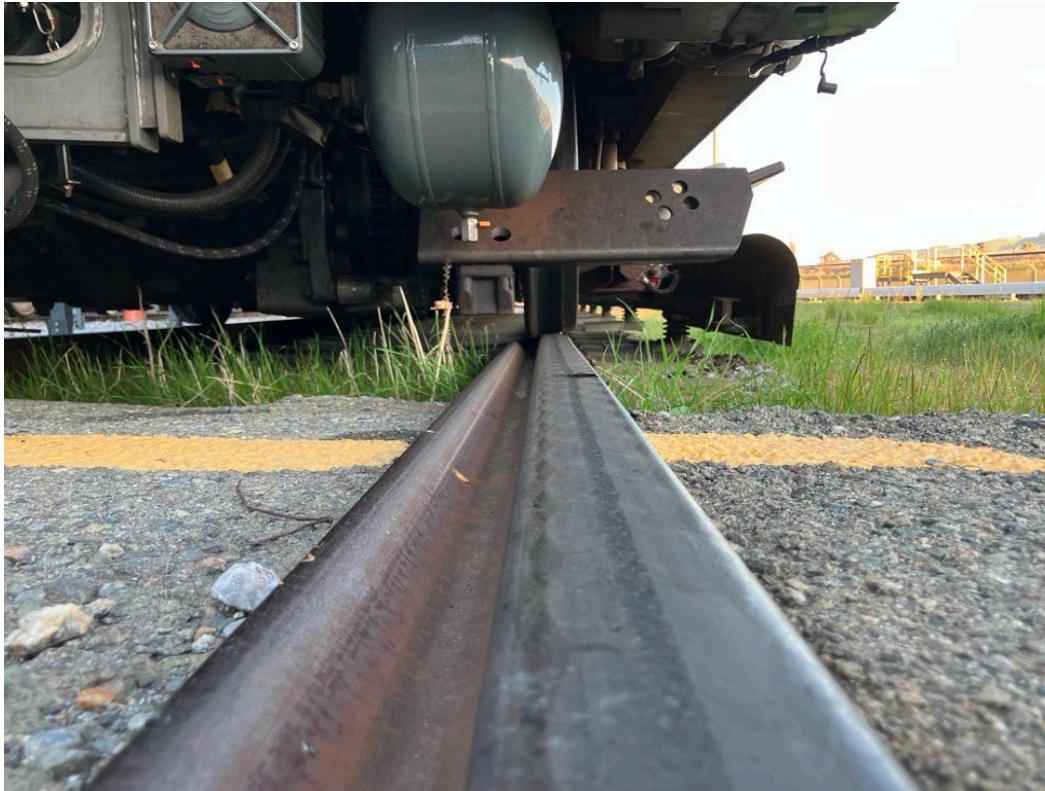
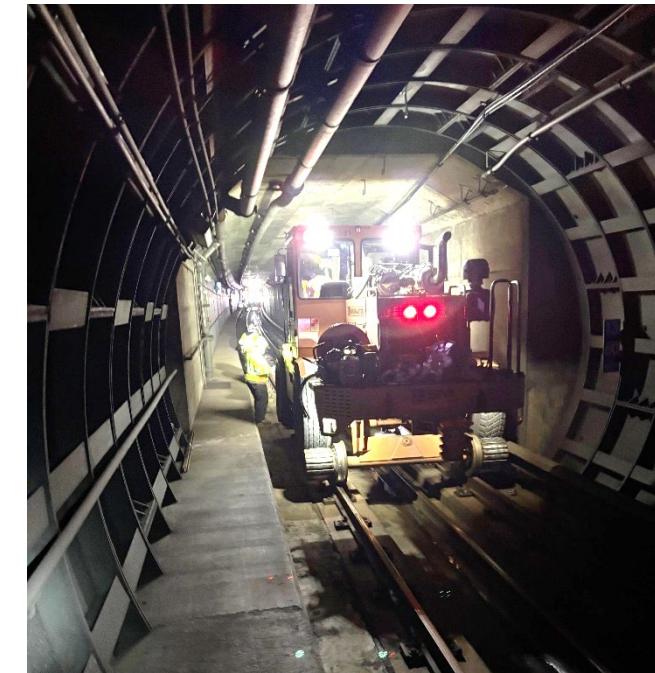
Track Power Vehicle Interface

- Natural movement and vibrations between the car and rail during normal operation, can briefly interrupt the interface between the Third Rail and the collector shoe paddle, resulting in normal momentary arcing.
- Potential increase in arcing between the Third Rail and paddles can be due to poor contact, rough track and contaminated surfaces, geometry misalignments or when one collectors carries most of the load.
