**Root Cause Investigation Findings**
M-Line Service Disruptions

June 11, 2026 | BART Board of Directors Meeting

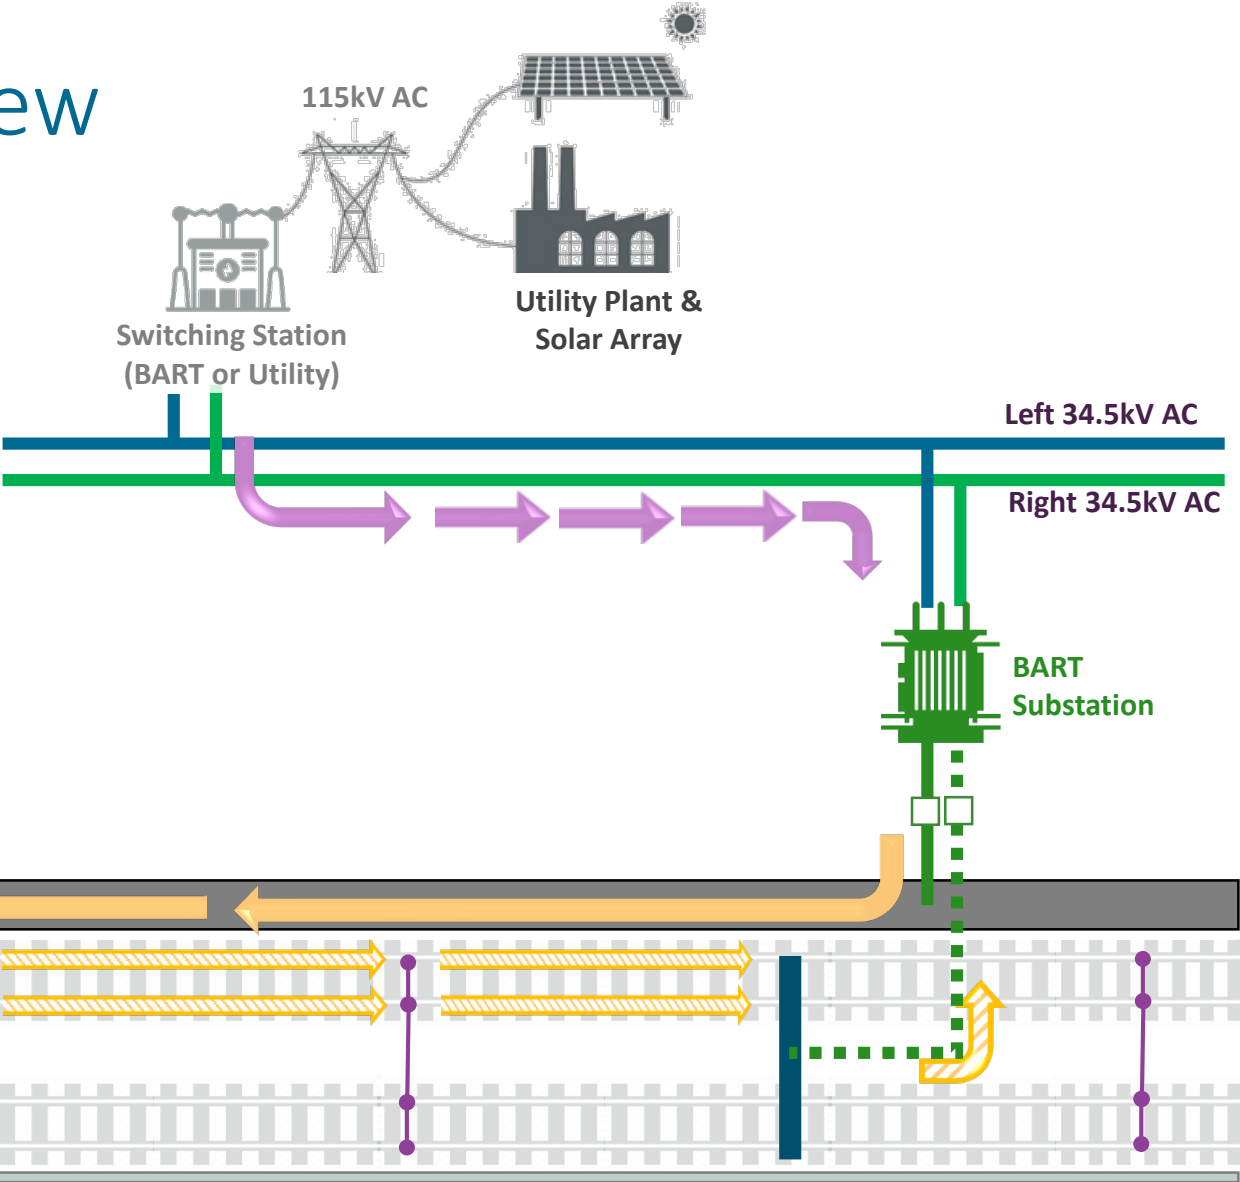
- Power comes from the power grid through the **Utility's Switching Station** at **115kV AC** into a **Switching Station**
- The Switching Station steps down **115kV AC** to **34.5kV AC** to the BART Substation
- BART Substation steps down and converts the **34.5kV AC** to **~1000V DC** and powers the **3rd Rail**
- The Collector Shoe assembly and paddle draw power from the **3rd Rail** to move the train and power auxiliary systems
- **Negative Return Current** is returned through wheels onto the running rails
- The running rails are connected via **Crossbonds** which helps balance the current flow
- The **Negative Return Shunt** (Impedance Bond) is connected via the **Negative Return Cable** back to the **Substation**

Negative Return Shunt		AC Current Flow
	Negative Return DC Cable		DC Positive Current Flow
	~1000V DC Feeder Cable		DC Negative Current Flow
	Crossbond		Breaker

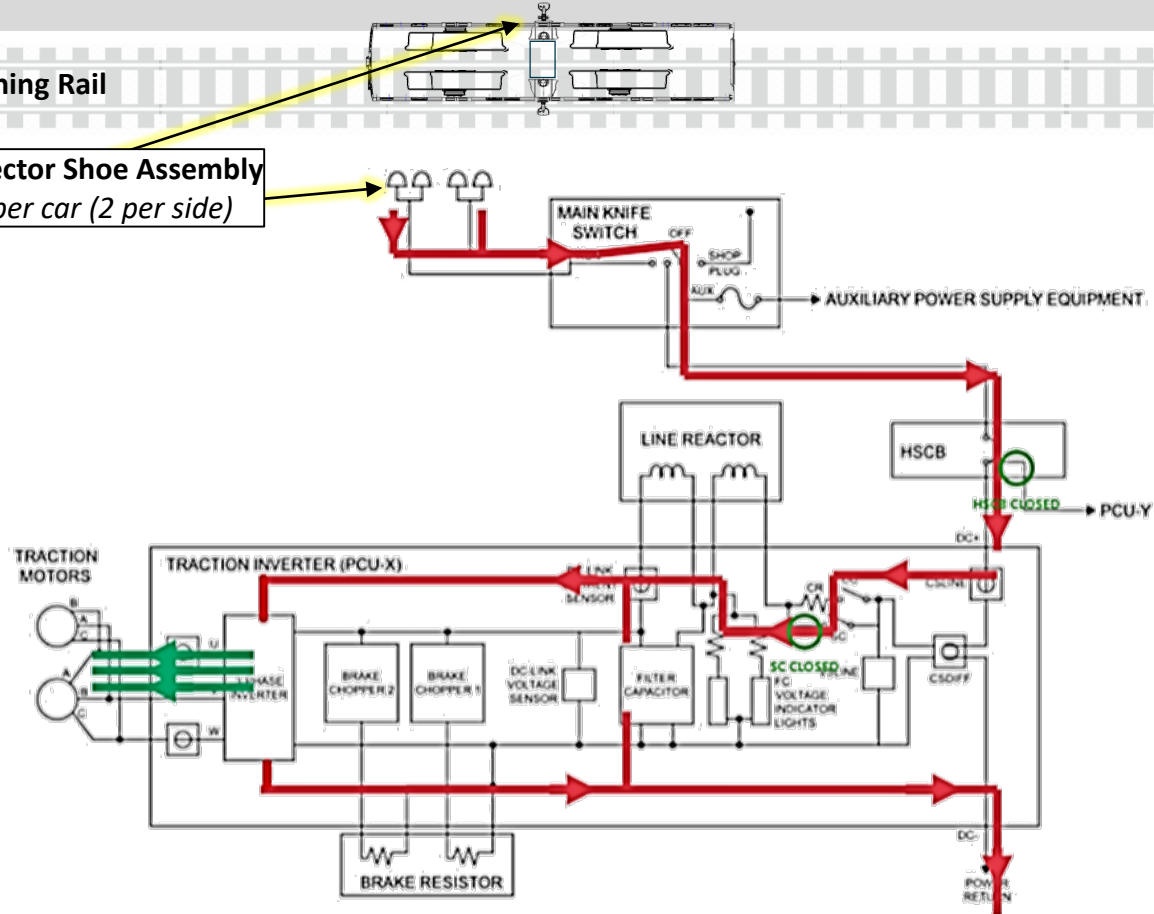
3rd Rail ~1000V DC

Running Rail

Collector Shoe Assembly
4 per car (2 per side)

Red line depicts schematic power flow within the vehicle

Power Returns to Running Rail
