Service Disruption Updates

May 9, 2025 – Operational Technology Network Disruption

May 20, 2025 – San Leandro Fault & Equipment Fire

BART Board of Directors | June 26, 2025

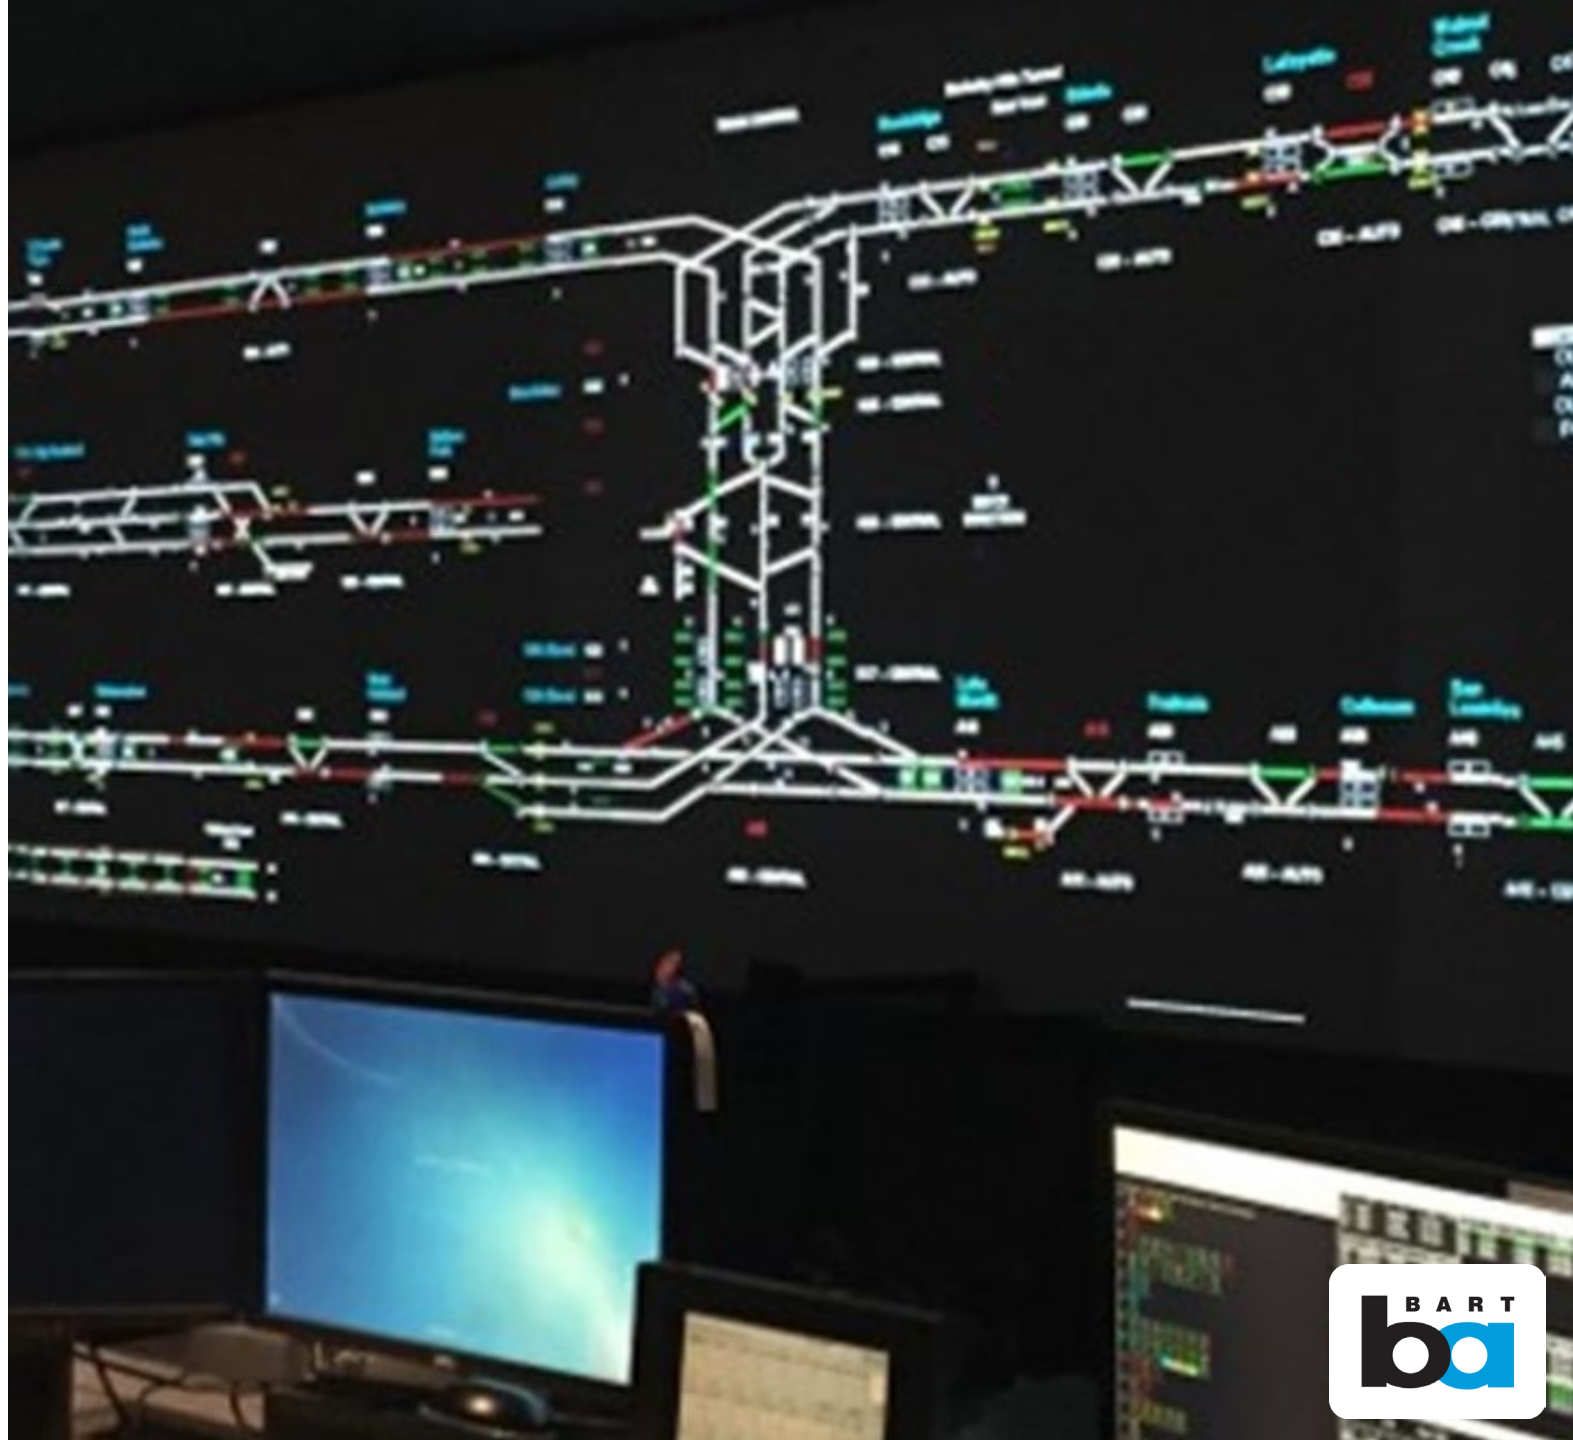
Network Disruption

Date: Friday, May 9, 2025

Time: Approximately 2:24 AM

A network looping event caused OCC to lose visibility and control of operating systems resulting in a delay to the start of revenue service

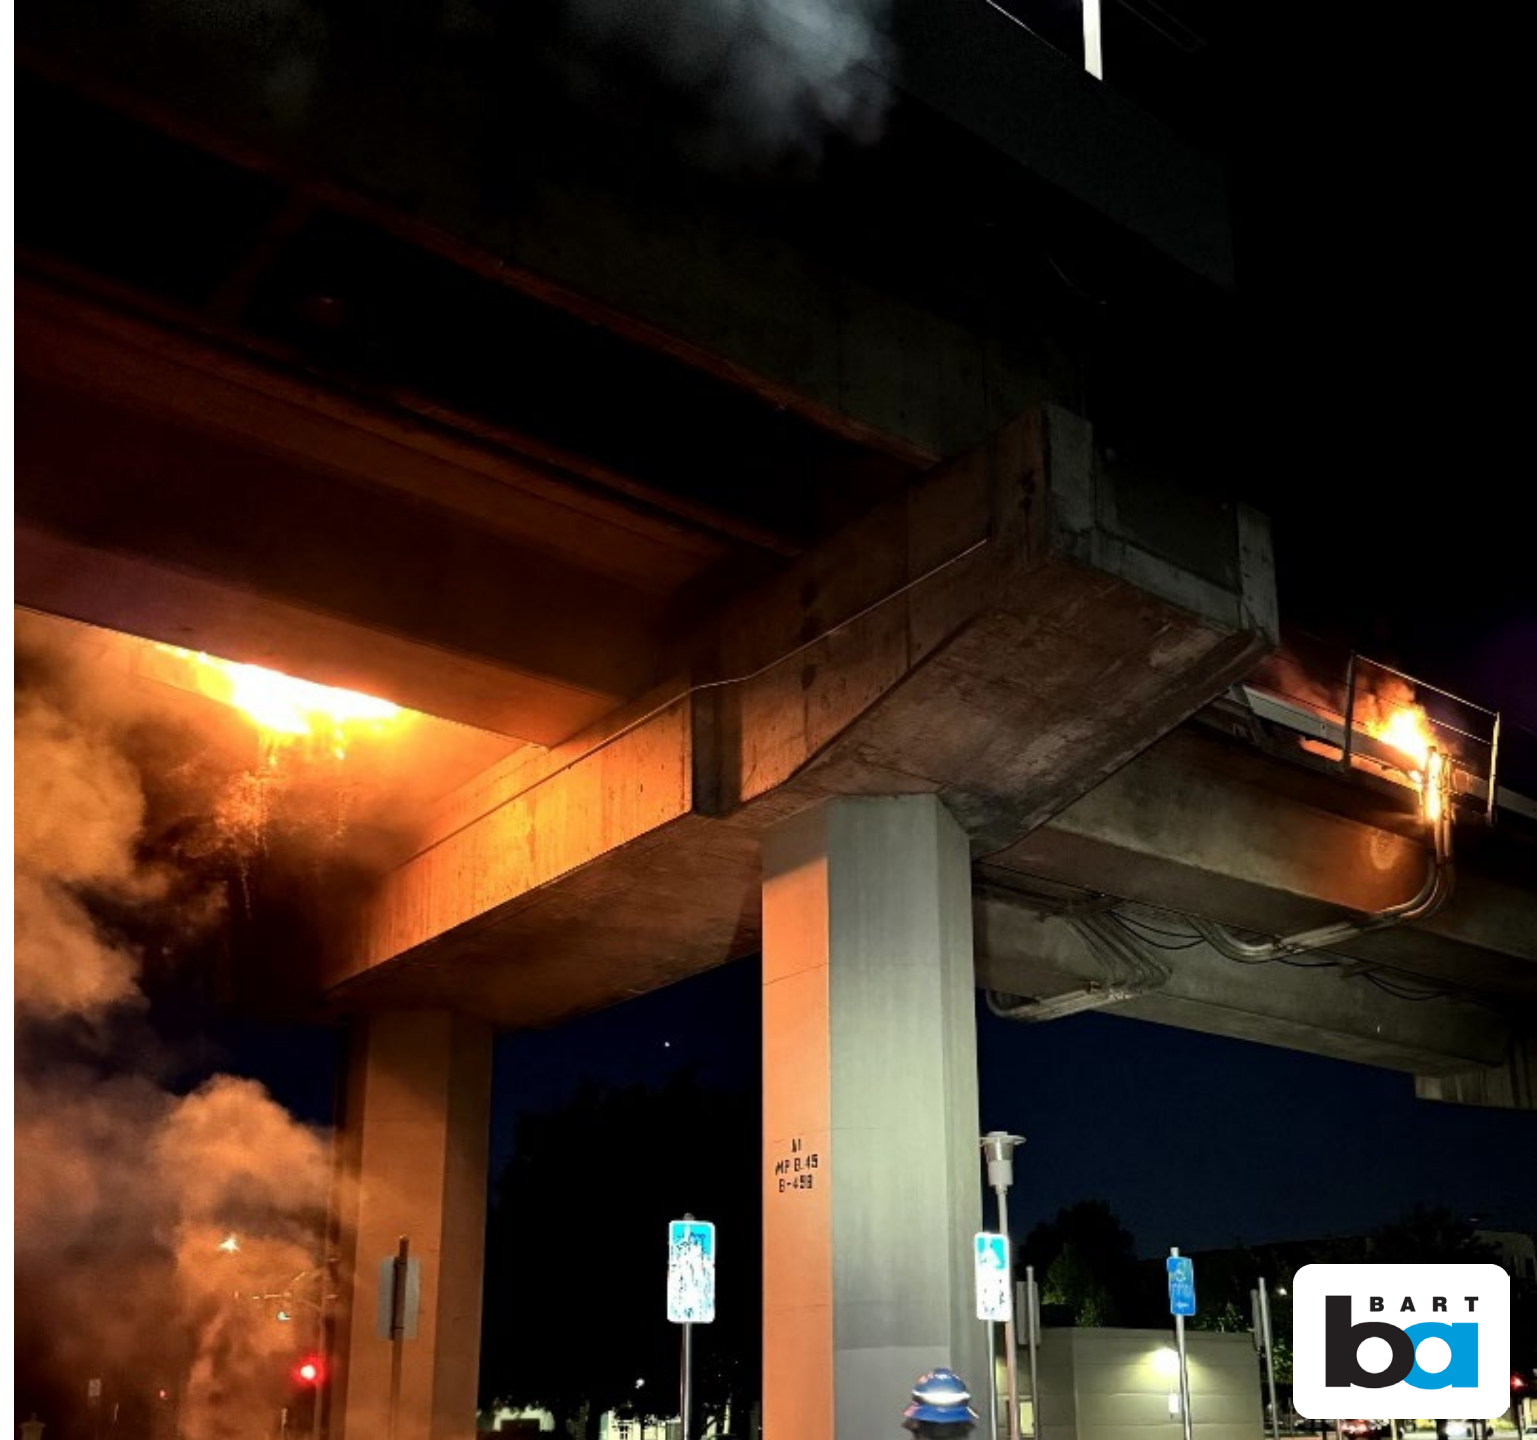
San Leandro Station Electrical Fault & Fire

Date: Tuesday, May 20, 2025

Time: Approximately 4:55 AM

- Closure of all stations south of Lake Merritt during the morning commute
- Immediate service suspension of Green, Orange, and Blue lines

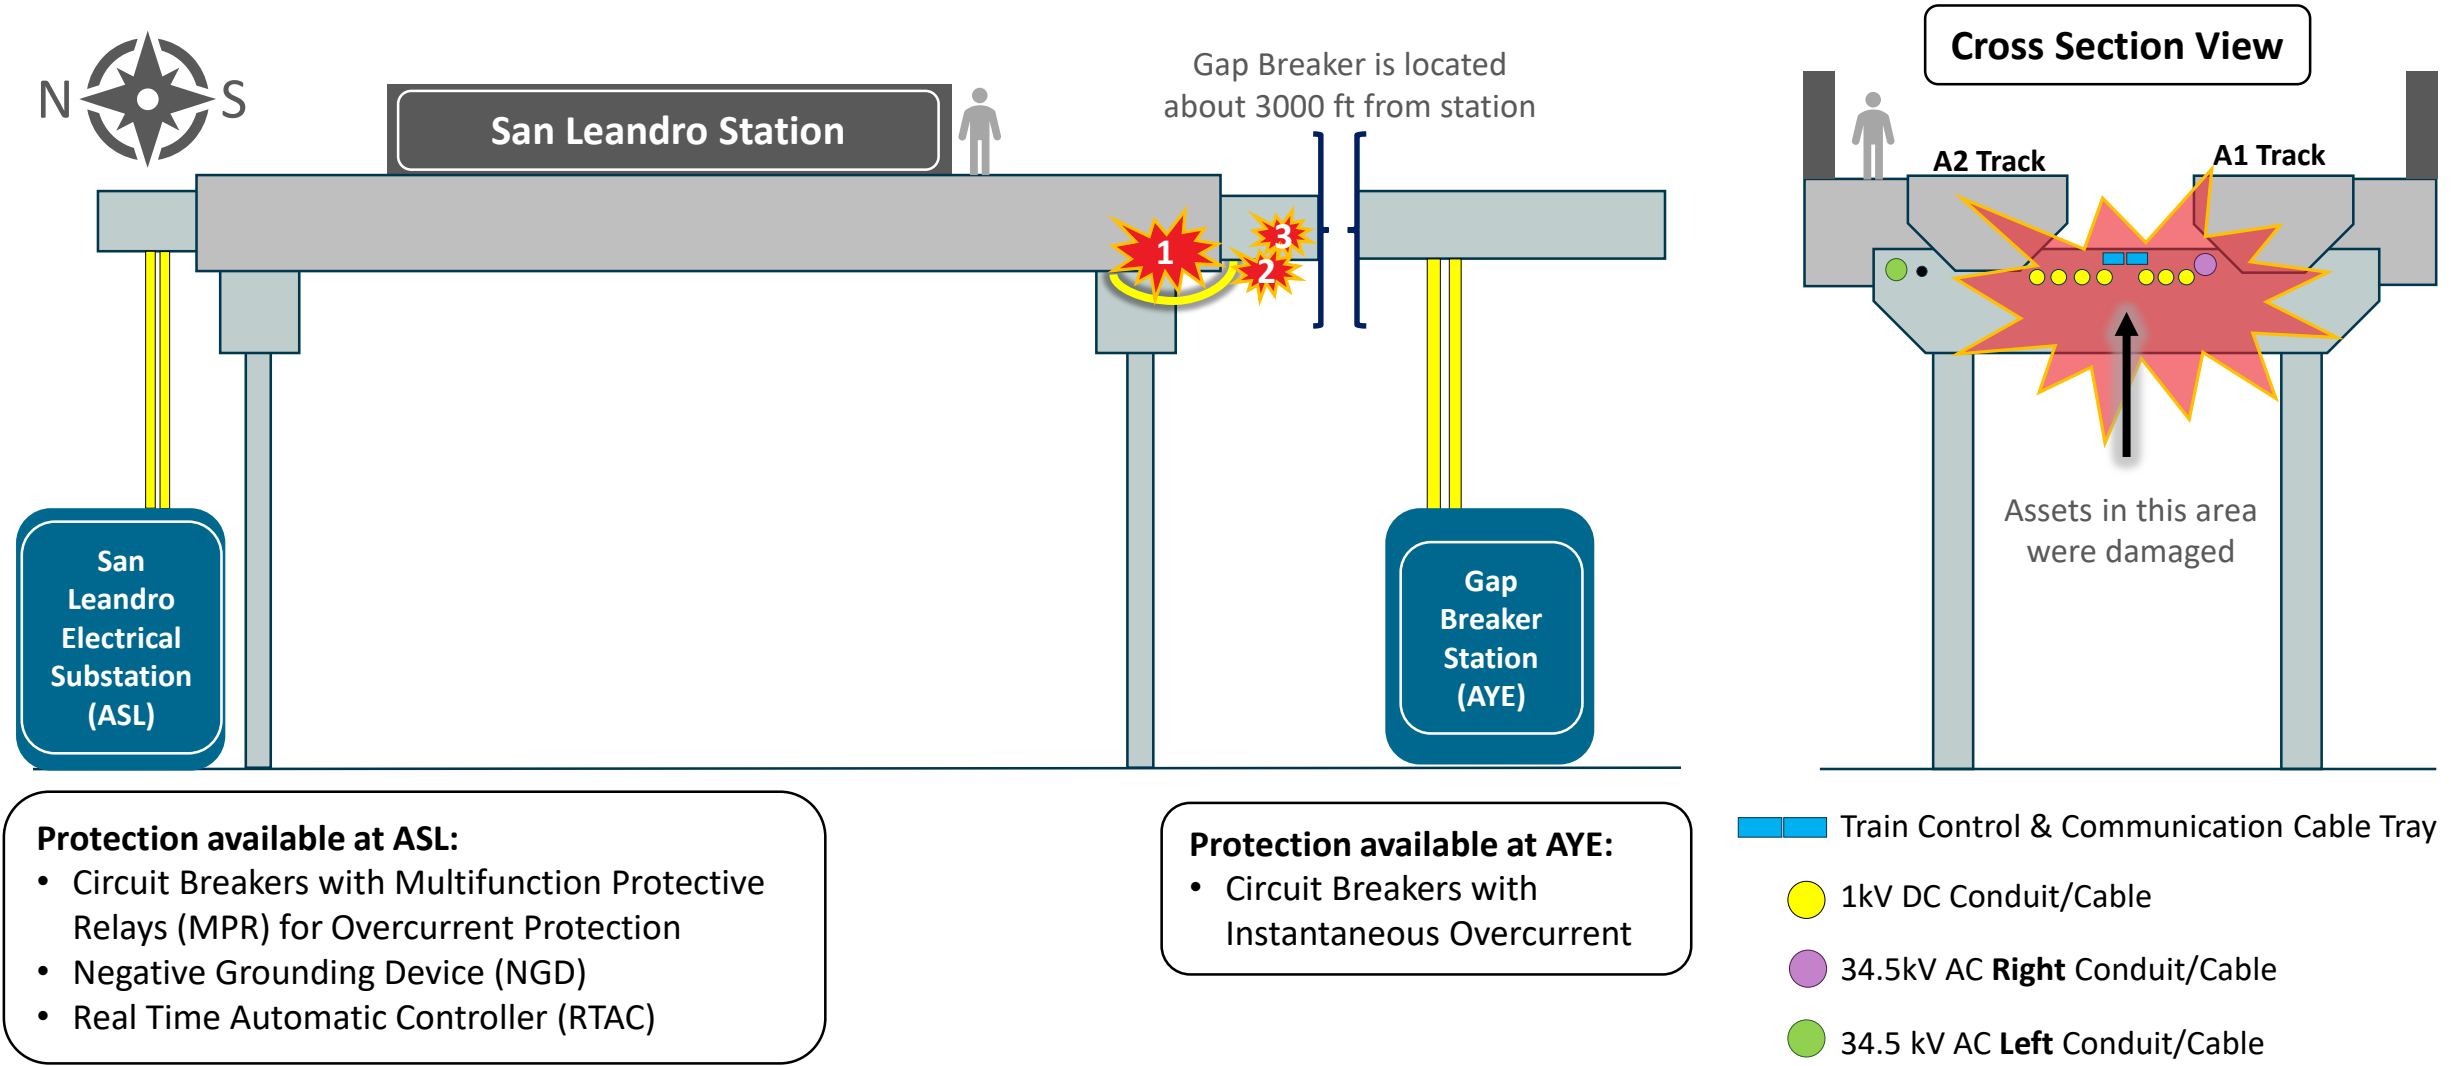
Incident Description

Initiating Cause: A low level Electrical fault (line to ground) in the 1kV DC power cable system

Fire and arc blasts caused damage to nearby 34.5kV cables, Train Control and Communications equipment propagating into additional faults and fires

Remote control ability from OCC was lost due to damaged to Train Control and Communications equipment

- ☐ Infrastructure Repairs & Replacement
- ☐ Install and adjust Protective Equipment Settings where needed
- ☐ Review Inspection and Maintenance Program, and Electrical Protection Schemes for enhancements

- ☐ Complete replacement of damaged assets
- ☐ Assess Power System Protection & Detection Improvement Opportunities
- ☐ Assess innovative tools and life cycle management improvement opportunities

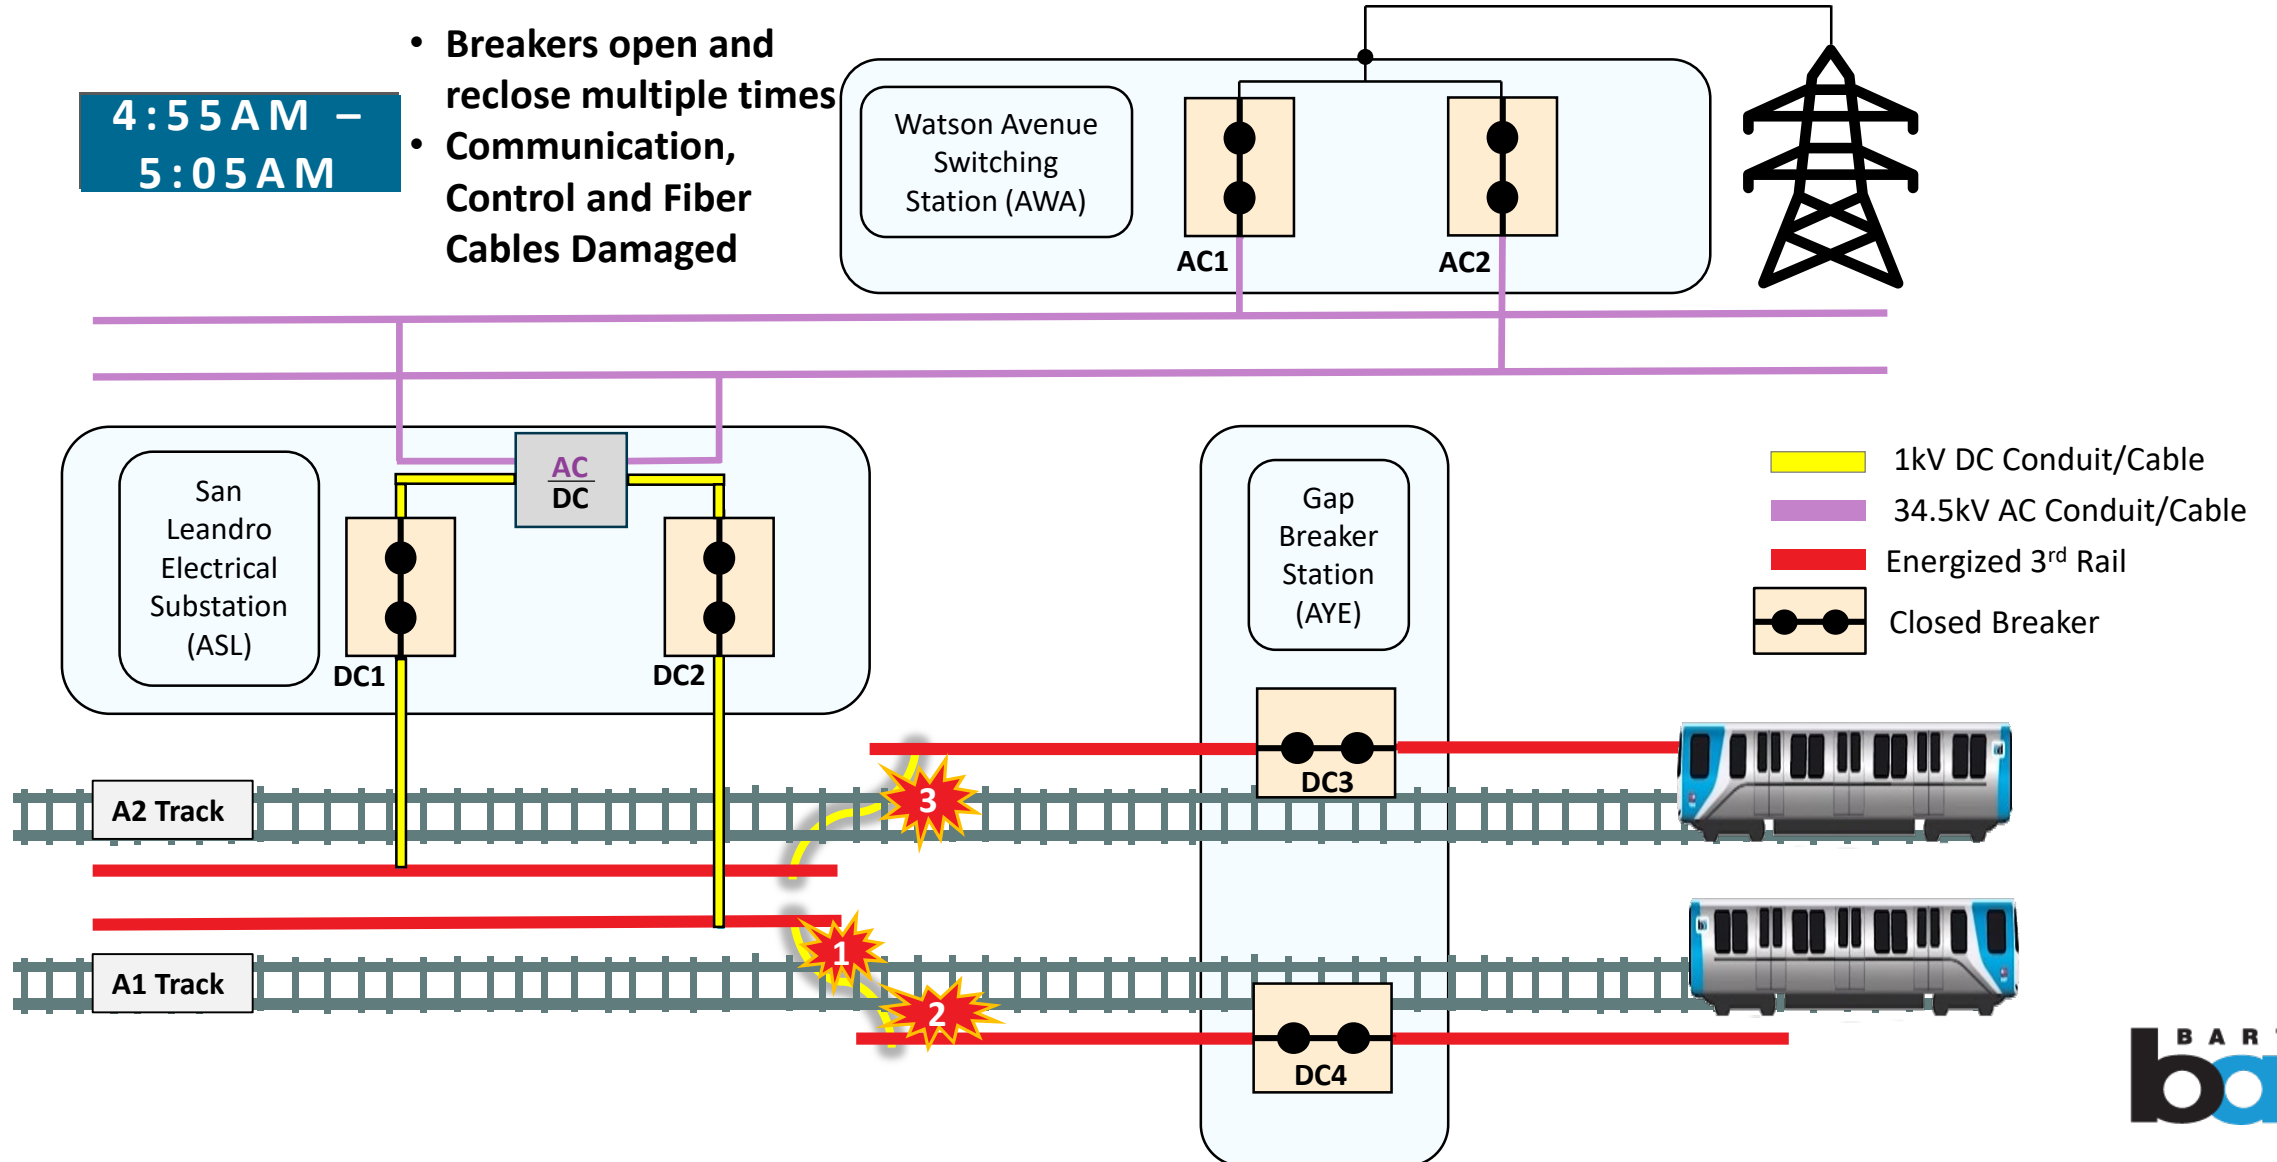
Sequence of Events

**4:55 AM –
5:05 AM**

- Breakers open and reclose multiple times
- Communication, Control and Fiber Cables Damaged
